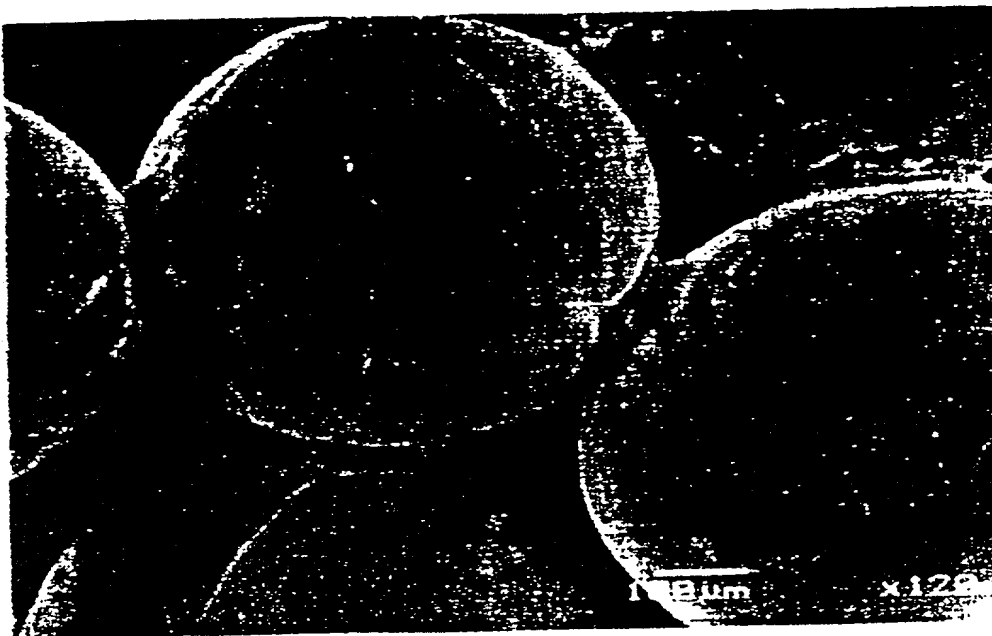
SEM micrographs of the Hayes CrCoMo sample after ASTM F746 corrosion test indicates intergranular corrosion attacks.

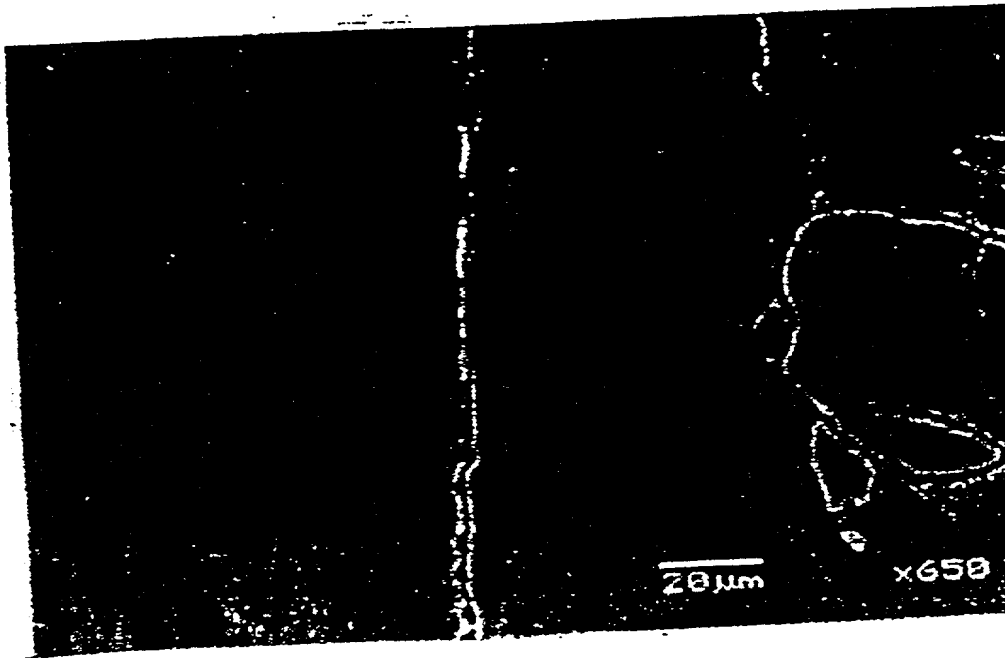
SEM micrographs of the Hayes CrCoMo sample after ASTM F746 corrosion test exhibiting corrosion attacks.
